NASA CR-135269

# **MANUFACTURE and ENGINE TEST of ADVANCED OXIDE DISPERSION STRENGTHENED ALLOY TURBINE VANES**

**FINAL REPORT**

**MATERIAL AND PROCESS TECHNOLOGY LABORATORIES  
AIRCRAFT ENGINE GROUP  
GENERAL ELECTRIC COMPANY  
CINCINNATI, OHIO 45215**

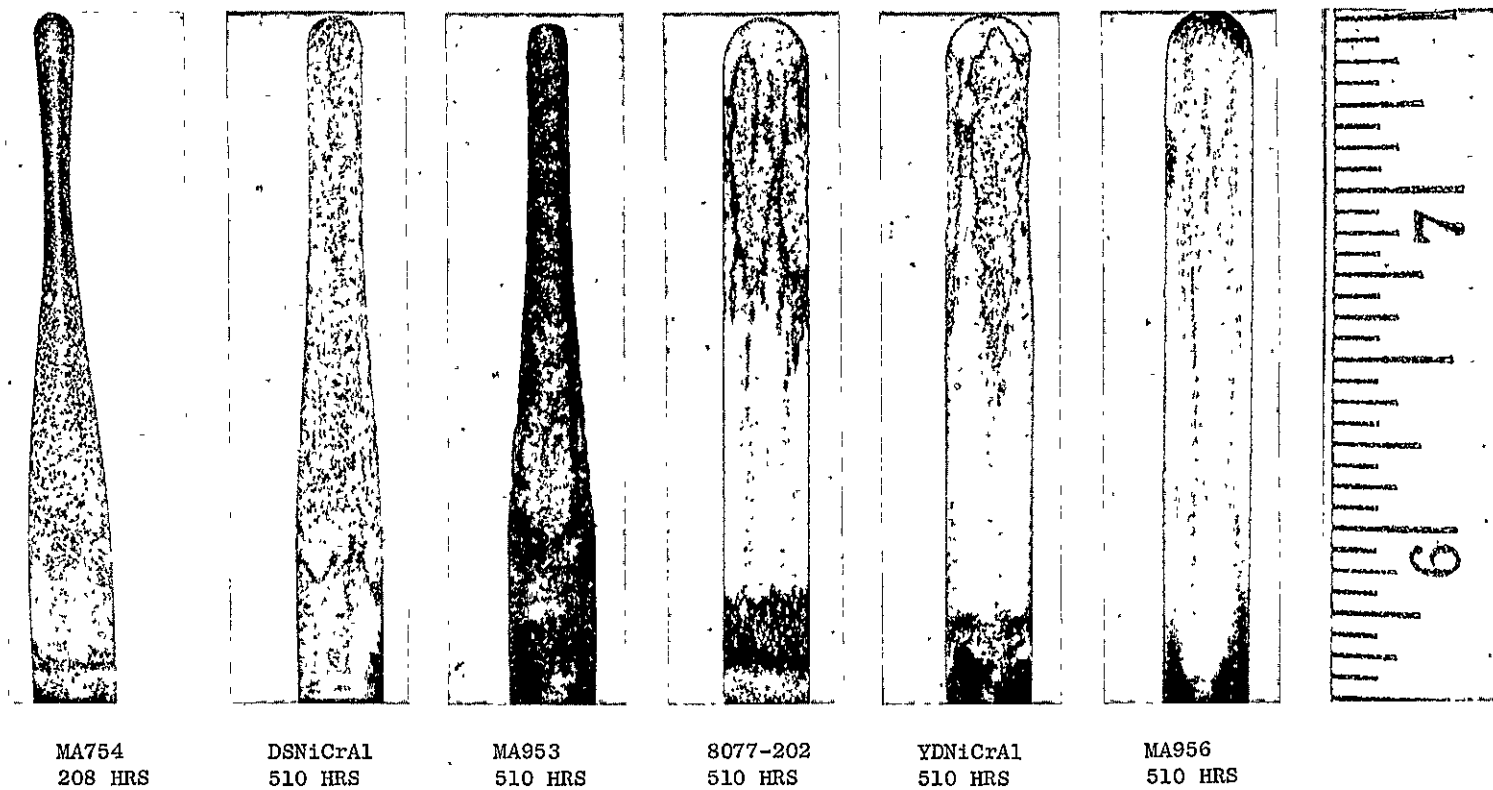
Figure 35 Selected 1204° C (2200° F) High Velocity Oxidation Pins at 2X

Continuation of the severe 1203° C (2200° F), Mach 1 oxidation testing beyond the ~200-hour point showed unexpected surface deterioration in both HDA 8077 and YD NiCrAl. In the same test, Sherritt-Gordon DS NiCrAl and MA 953 (early nonhomogeneous materials) were nearly consumed; these and other effects are shown in Figure 35. MA 956 (Fe-Cr-Al) continued to show excellent oxidation resistance. MA 754 was removed at the 208-hour point because of serious material loss, also shown in Figure 35.

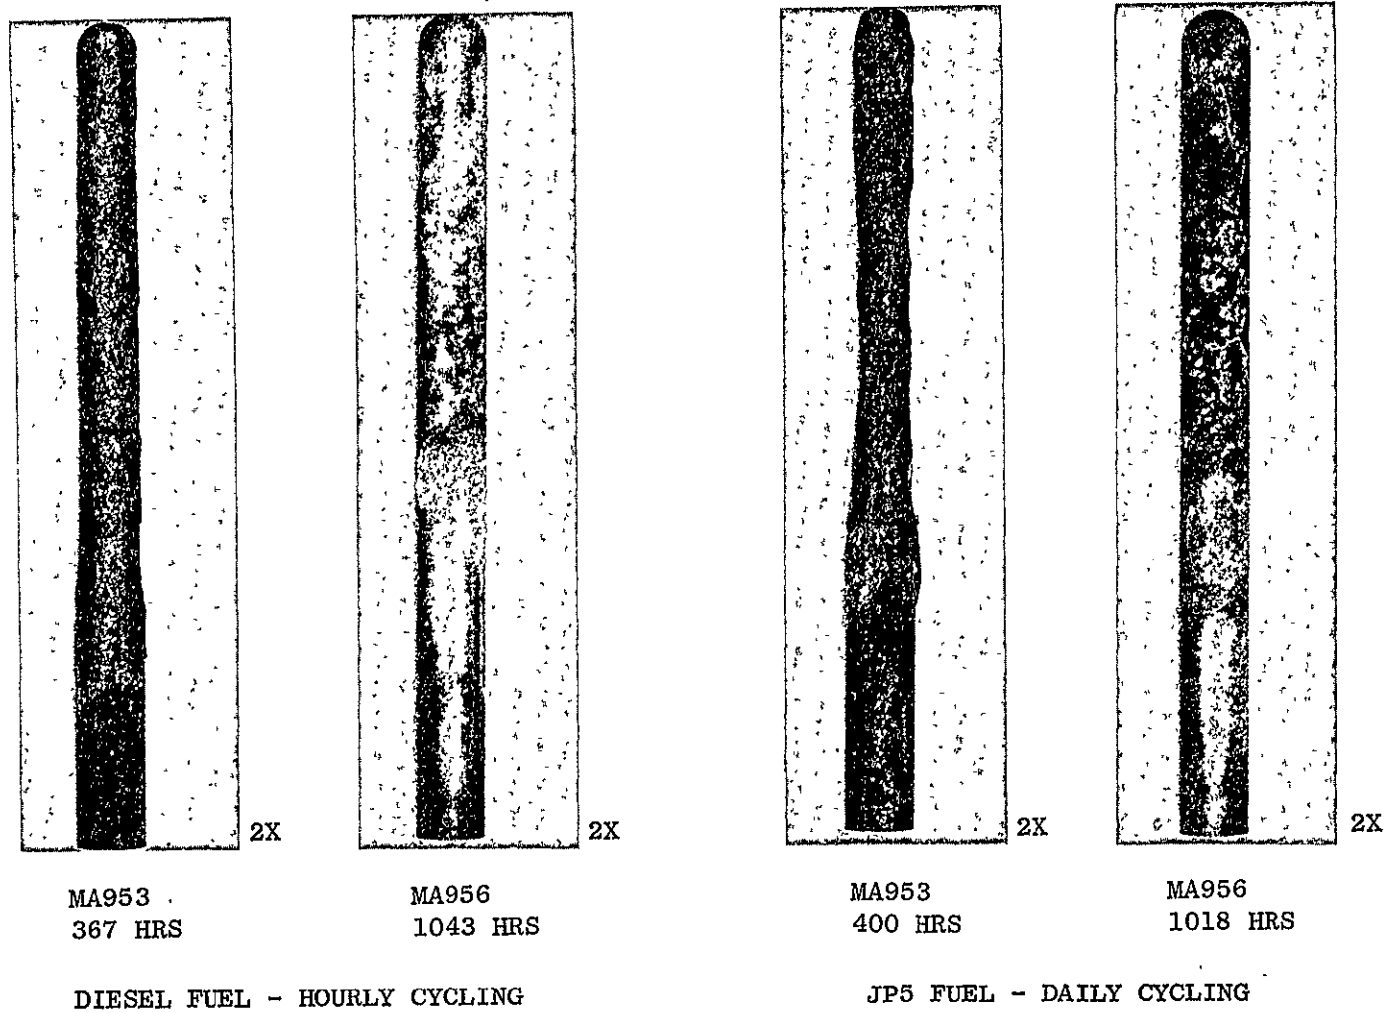
Figure 43 MA953 and MA956 Hot Corrosion Pins

926°C (1700°F) - 5 PPM SALT - LOW VELOCITY

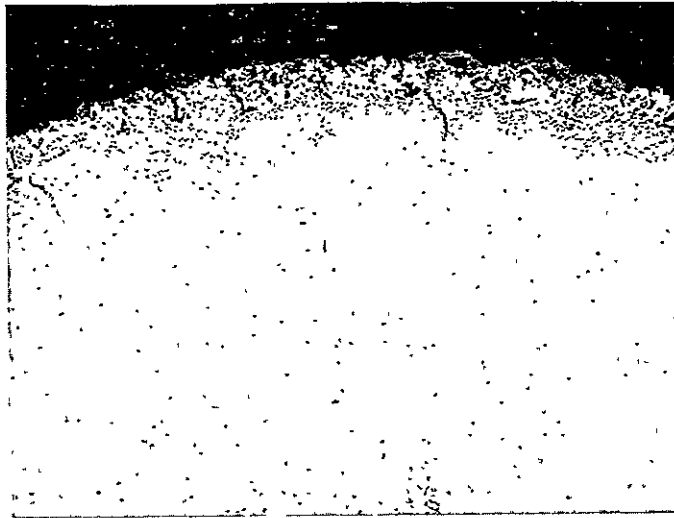
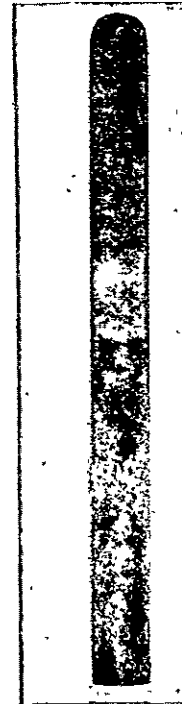
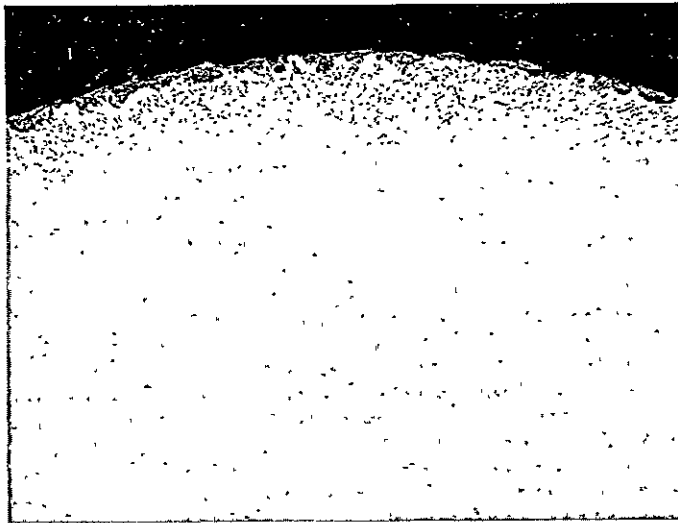
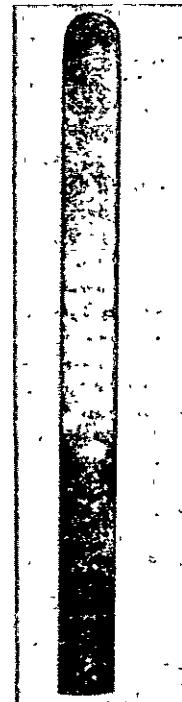
Figure 44 MA754 Hot Corrosion Pins

885 HRS DIESEL FUEL - HOURLY CYCLING

1018 HRS JP5 FUEL - DAILY CYCLING

926°C (1700°F) - 5PPM SALT - LOW VELOCITY

Microexamination of the samples revealed subsurface attack on the HDA 8077 and MA 754 that was not evident from visual inspection. Estimates of average surface attack depth for these two alloys and MA 956 are as follows:

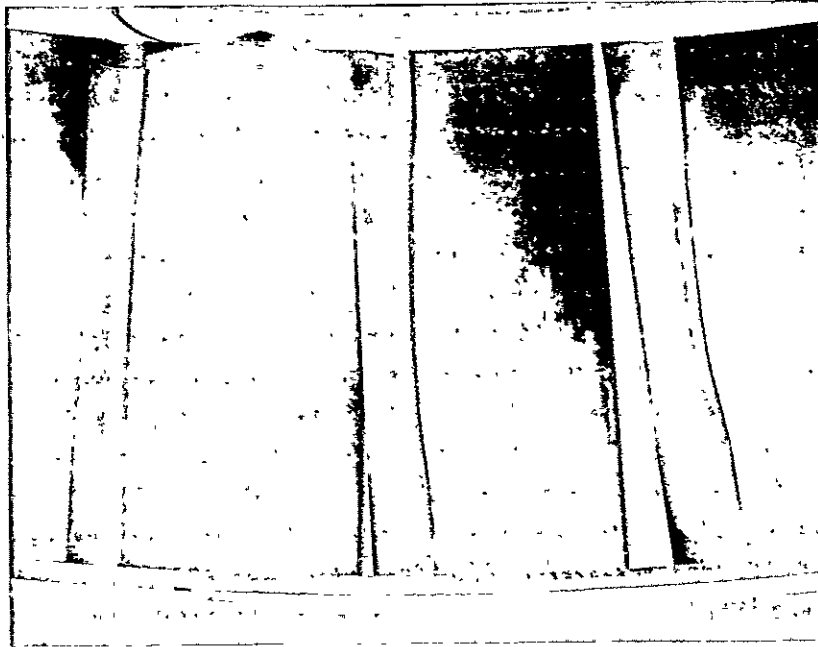
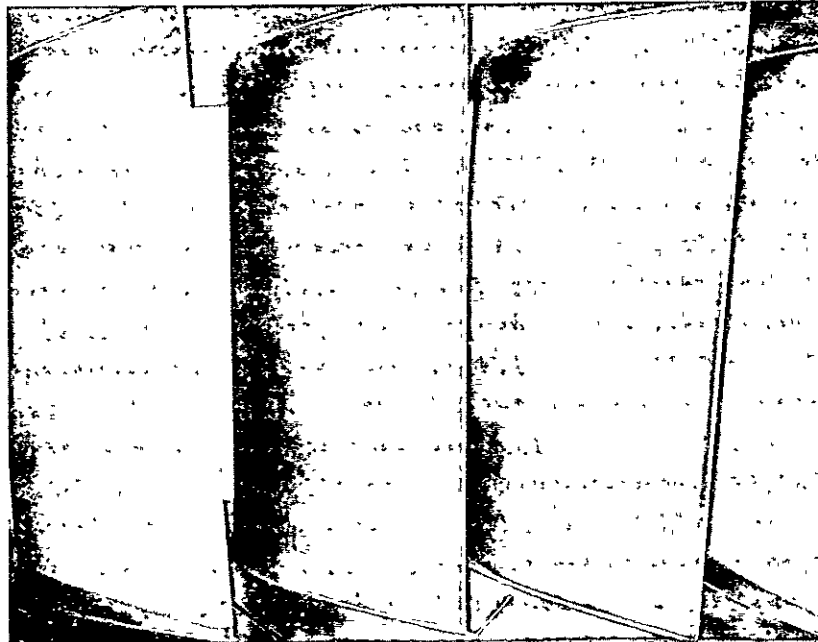
Figure 60 LPT Engine Test of HDA 8077, Bare & Coated  
MA 754 Vanes

All the ODS LPT vanes looked good on visual inspection as is shown in Figure 60, which depicts uncoated HDA 8077 vanes and bare and coated MA 754 vanes. On a negative note, what the photographs don't show is the green oxide on the HDA 8077 vanes in contrast to the silver color of the Ni-Cr-Al-Y coated MA 754 vanes. This indicates that the HDA 8077 vanes had not formed a protective Al<sub>2</sub>O<sub>3</sub> surface, while the coated MA 754 vanes had. The HDA 8077 vanes did have a more uniform oxide film than the bare MA 754 vanes, however.

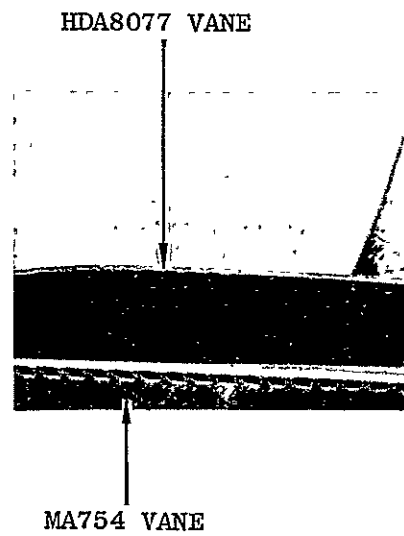
Figure 62 HDA 8077 Vane Trailing Edge Bowing, F101 HPT Test

In addition to the increased cracking observed in HDA 8077 and YD NiCrAl, relative to MA 754, several surface attack effects were noted. A subsurface oxide buildup occurred in the trailing-edge cooling-hole area that was not observed on MA 754. The effect is shown in Figure 78. This is one of the hotter zones of the vane. It should be noted that the effect occurs both on the outside vane surface and inside the cooling hole. The attack was observed to a distance of approximately 8.9 mm (0.35 inch) from the hole exit. A study employing Scanning Electron Microscopy (SEM) and Energy Dispersive Analysis of x-rays (EDAX), Figure 79, failed to pinpoint external contamination as a cause of the unusual attack. The SEM/EDAX analyses of the oxide particles show a substantial aluminum oxide content, indicating that they were formed by internal oxidation. The EDAX analyses of the areas between the particles show practically no aluminum from the vane surface through the oxide particle area. The chromium in this zone is depleted also. It is postulated that the engine environment prevented formation of a protective  $\text{Al}_2\text{O}_3$  scale and that this lack of a protective scale allowed internal oxidation to take place.

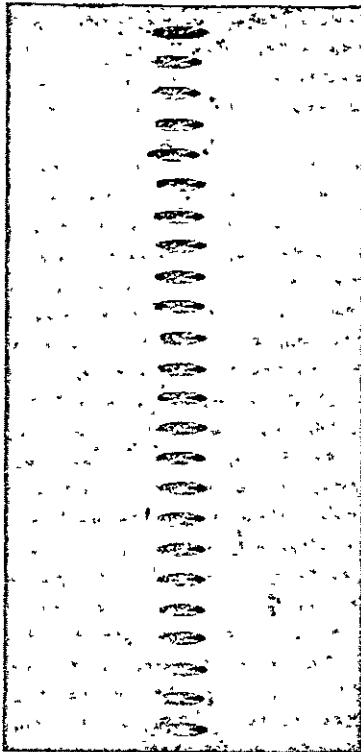
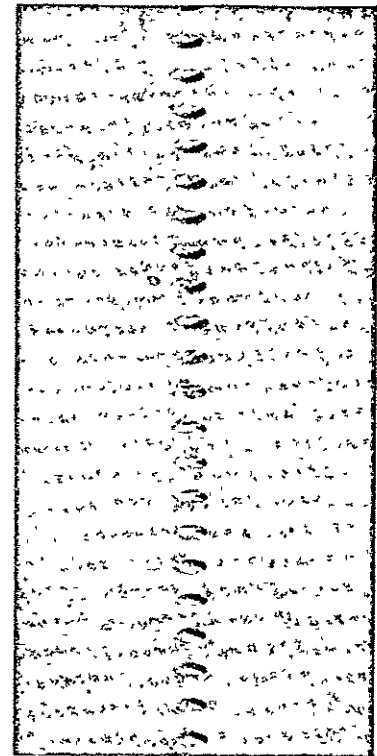
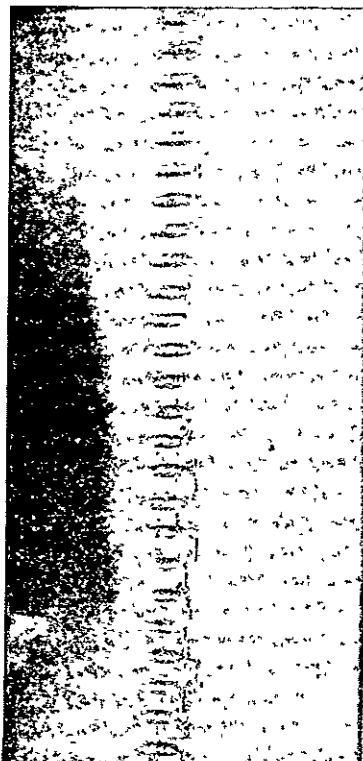
HDA8077  
VANES

The engine was run for 105 hours and 200 cycles before the first tear-down. Examination in the "dirty" condition showed the YD NiCrAl and MA 754 vanes in satisfactory condition, but the HDA 8077 vanes exhibited trailing edge bowing (Figure 62) and severe cracking. Two of the six HDA 8077 vanes had band-to-band suction-side (convex) cracks. Closeup views of two pressure-side hole rows in HDA 8077 and MA 754 vanes, Figure 63, show the absence of surface cracking in the MA 754 vanes.

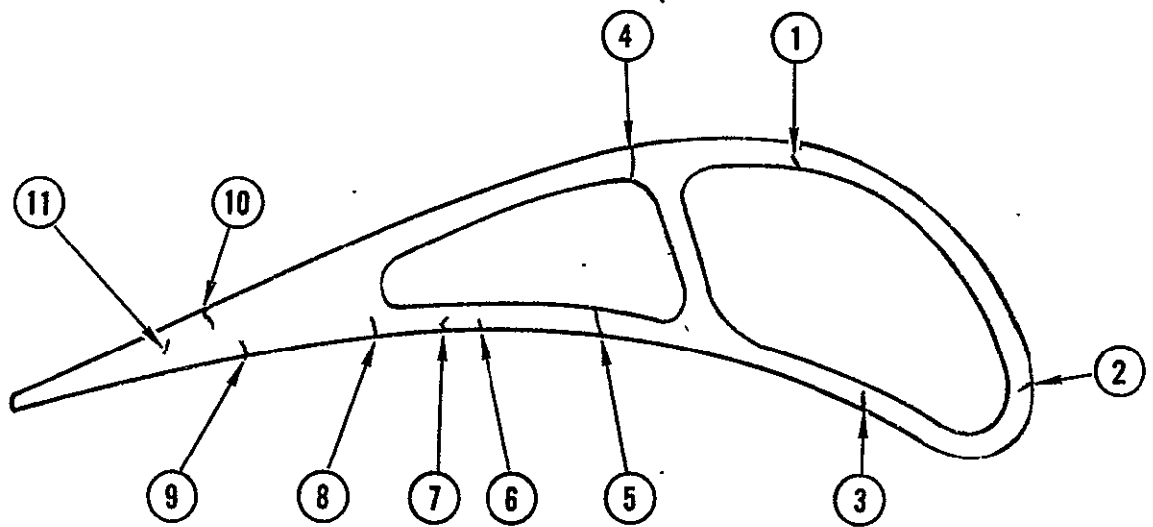
Figure 64 HDA 8077 Vane Crack Locations, F101 HPT Test

After removal of the HDA 8077/MA 754 vane segments, the engine test was continued to the 315-hour/699-cycle point and again torn down for examination. Macro examination of the vanes showed, unexpectedly, considerable distress on the YD NiCrAl vanes and still only minor effects on the MA 754. Figure 72 shows large displacement trailing edge bowing on the YD NiCrAl vanes and some also on the MA 754 vanes. Figure 73 shows surface cracking on the YD NiCrAl vanes. Figure 74 pictorially displays the location of cracking observed in the cut-up microexamination of the vanes. Typical microsections of the vanes are shown in Figures 75 through 77 in the same format as that done earlier for the HDA 8077 and MA 754 vanes.

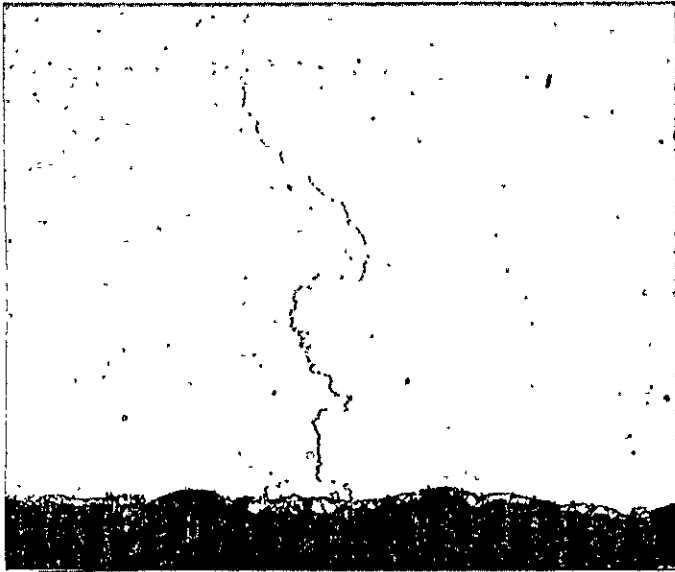
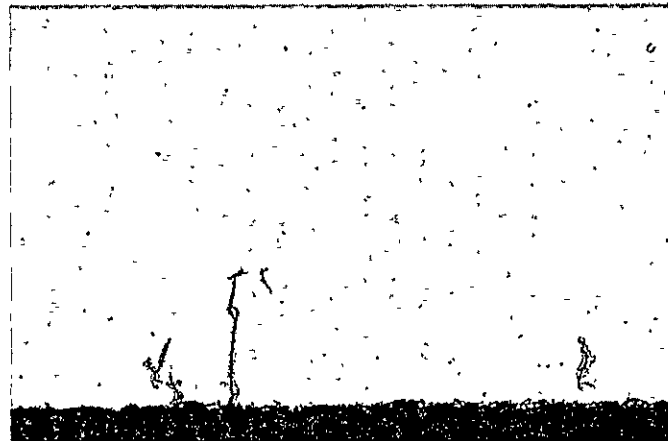
Figure 65 HDA 8077 Lead Cavity Microsections F101 HPT Test

Cutup of two of the HDA 8077 vanes showed considerable cracking in addition to that visible on the outer surfaces. Figure 64 shows the location of the major cracks. In Figures 65, 66, and 67, the cracks are shown in microsections of the leading edge/forward cavity, the aft cavity, and trailing edge, respectively. Similar views of the companion MA 754 vanes are shown in Figures 68 through 71. For outside surface closeups of the MA 754 vanes, refer back to Figure 63. The marked difference between the vane materials is clearly evident; the MA 754 vanes are not bowed, there are no through-the-wall fractures, and the secondary cracking is considerably less. Most of the HDA 8077 cracks occurred under tensile or rupture conditions. This is indicated by the fact that they followed the irregular grain boundaries. Several of the cracks, however, appear to be by low cycle fatigue as indicated by the straight-line transgranular propagation shown in Figure 67.

LOCATION 1 INNER WALL SUCTION SIDE

LOCATION 2 LEAD EDGE COOLING HOLE

LOCATION 3 OUTER WALL PRESSURE SIDE

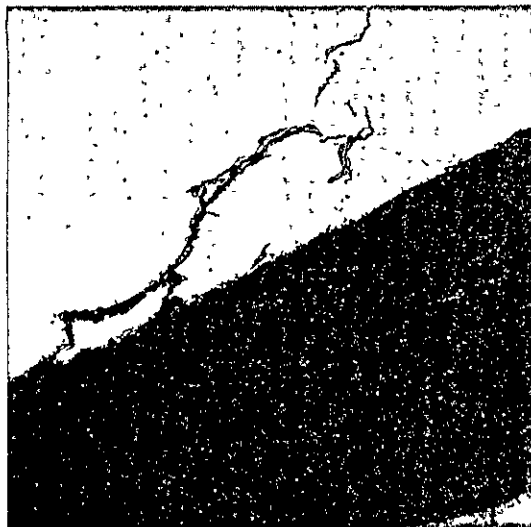
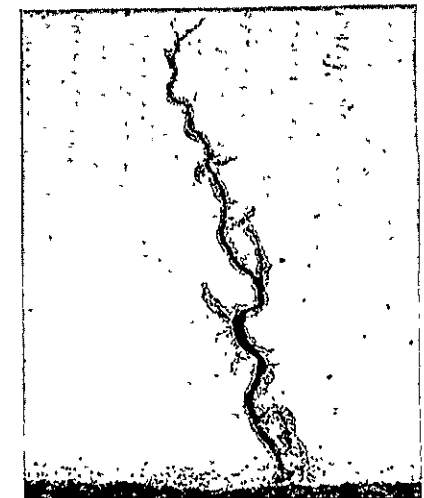
LOCATION 7 COOLING HOLE

LOCATION 6 PRESSURE SIDE OUTER  
SURFACE

LOCATION 5 PRESSURE SIDE  
OUTER-SURFACE.

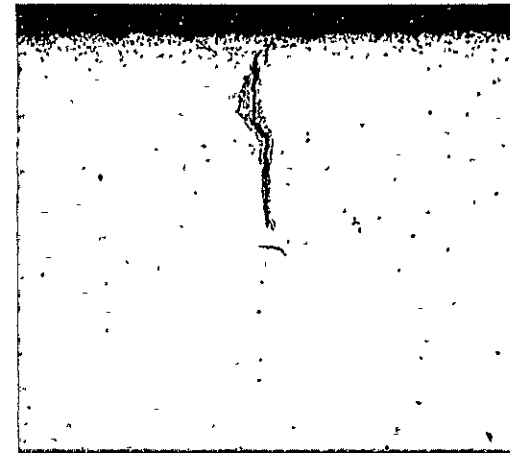
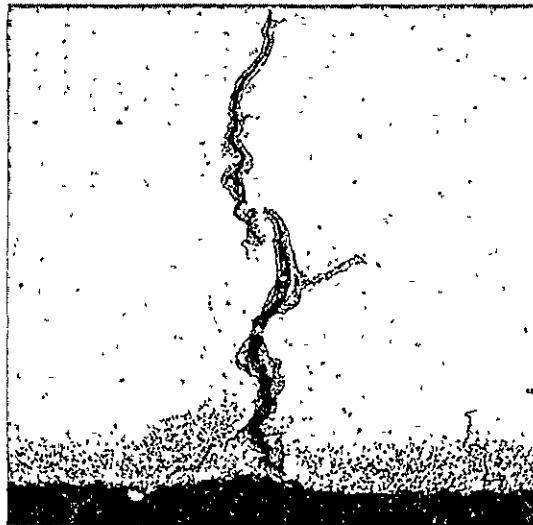
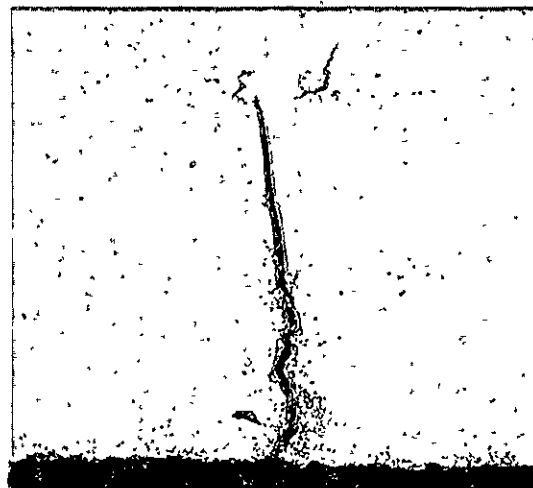
LOCATION 11 COOLING HOLE SURFACE

LOCATION 10 SUCTION  
SIDE OUTER SURFACE

LOCATION 9 PRESSURE SIDE SURFACE

LOCATION 8 PRESSURE  
SIDE SURFACE

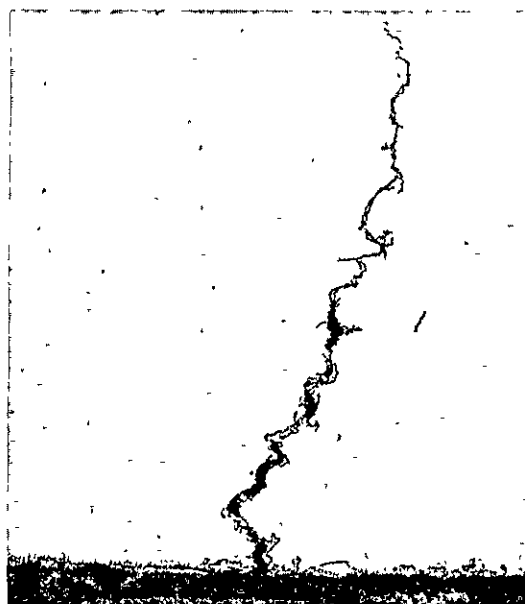
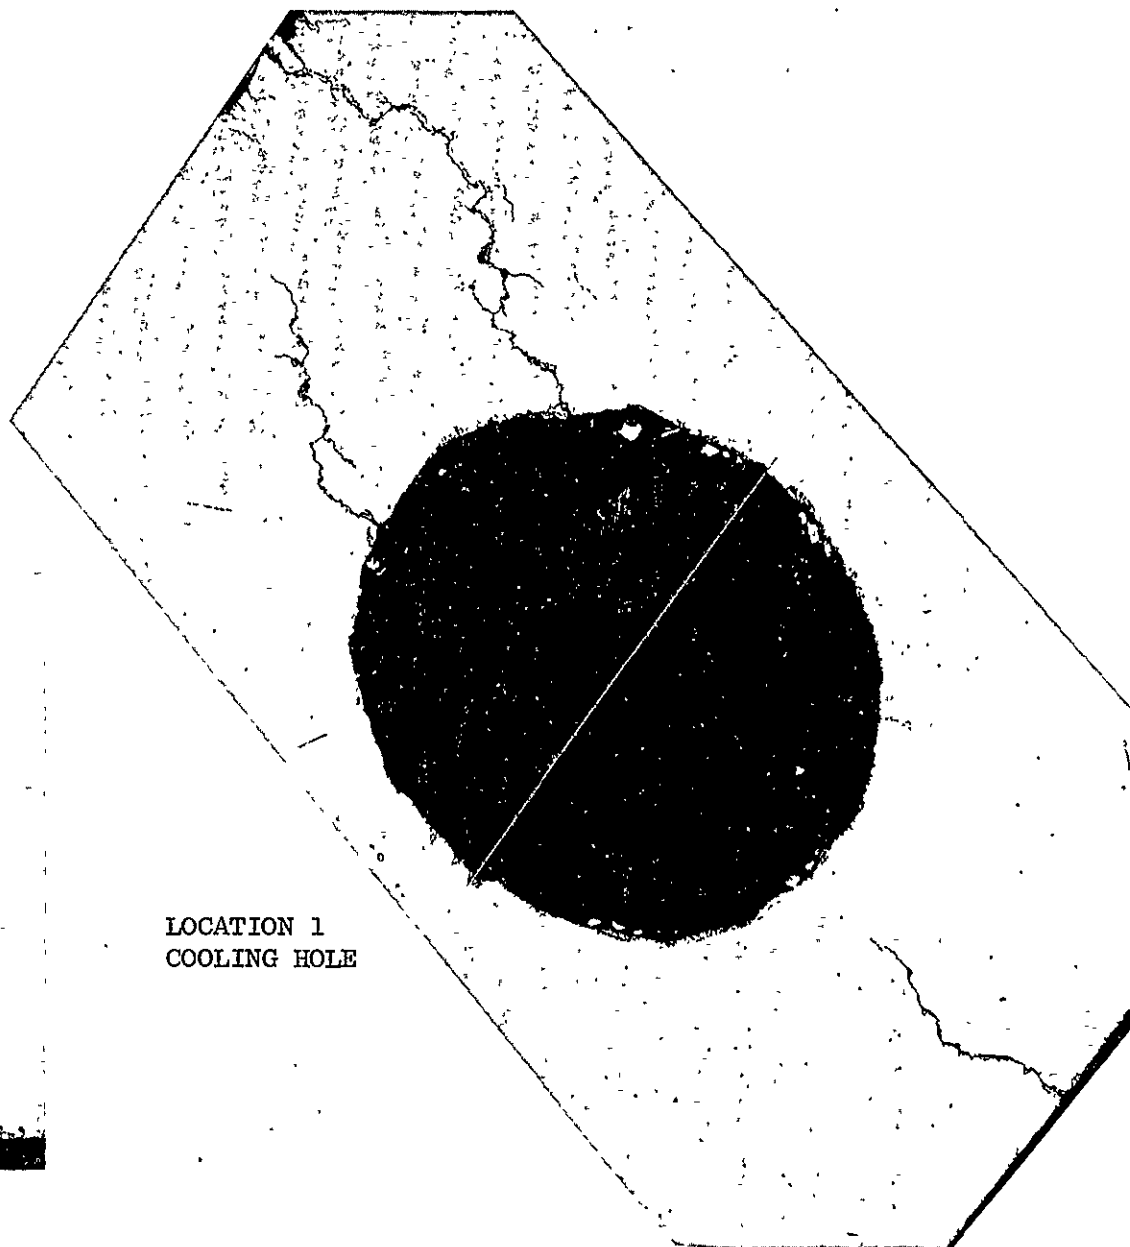
Figure 69 MA 754 Lead Cavity Microsections F101 HPT Test

LOCATION 2 PRESSURE  
SIDE OUTSIDE SURFACE

LOCATION 1  
COOLING HOLE

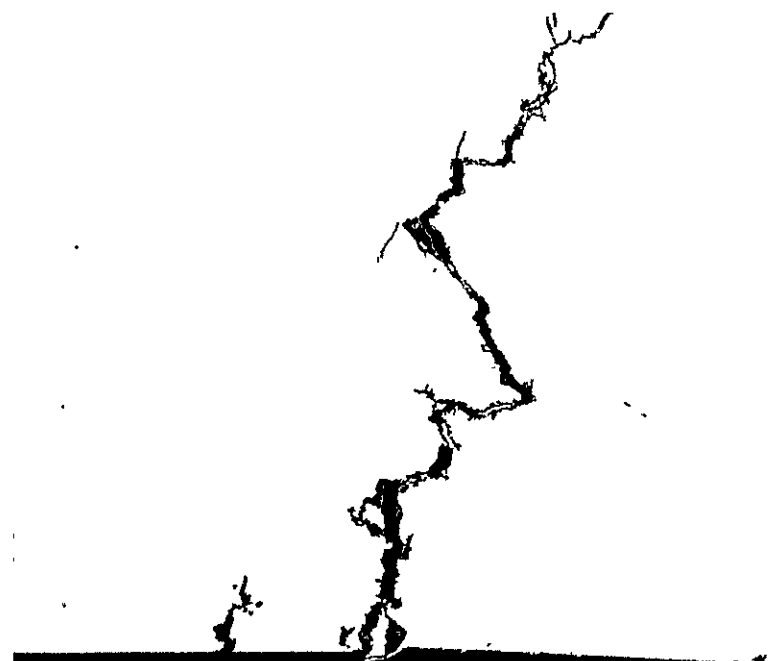
LOCATION 4 INNER SURFACE

LOCATION 3 OUTER SURFACE

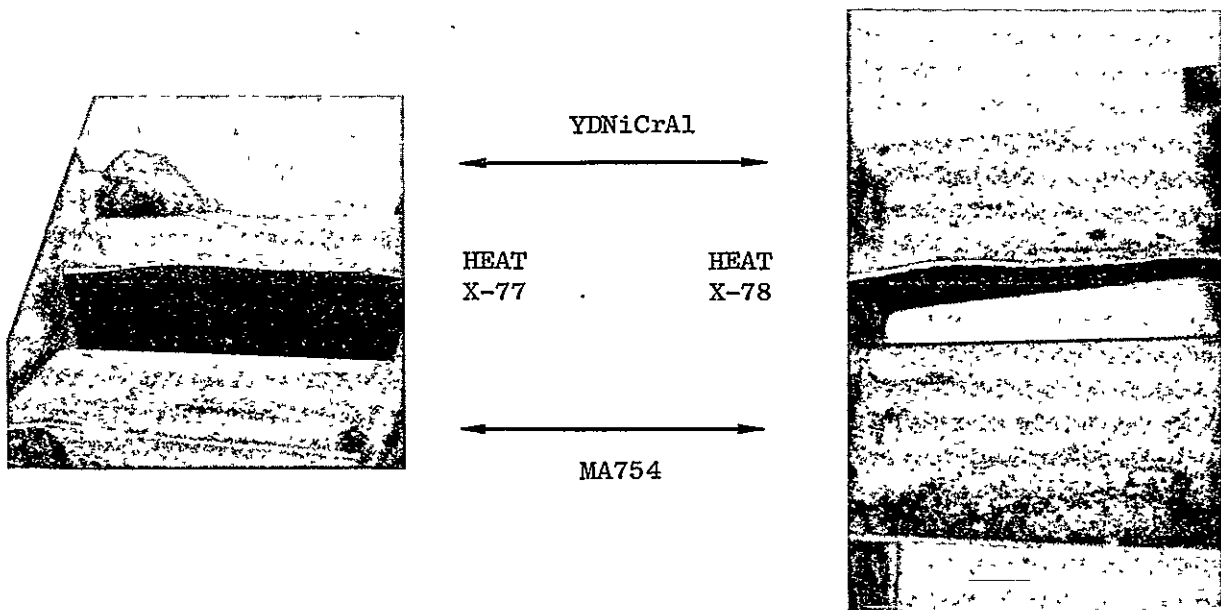
Figure 72 YD NiCrAl Trailing Edge Bowing F101 HPT Test

The engine testing which showed reduced resistance to vane wall cracking and trailing edge bowing with YD NiCrAl and especially HDA 8077 is difficult to explain fully, even considering the HDA 8077 grain boundary phase. We don't really have a good explanation of why the ODS-NiCrAls are inferior in

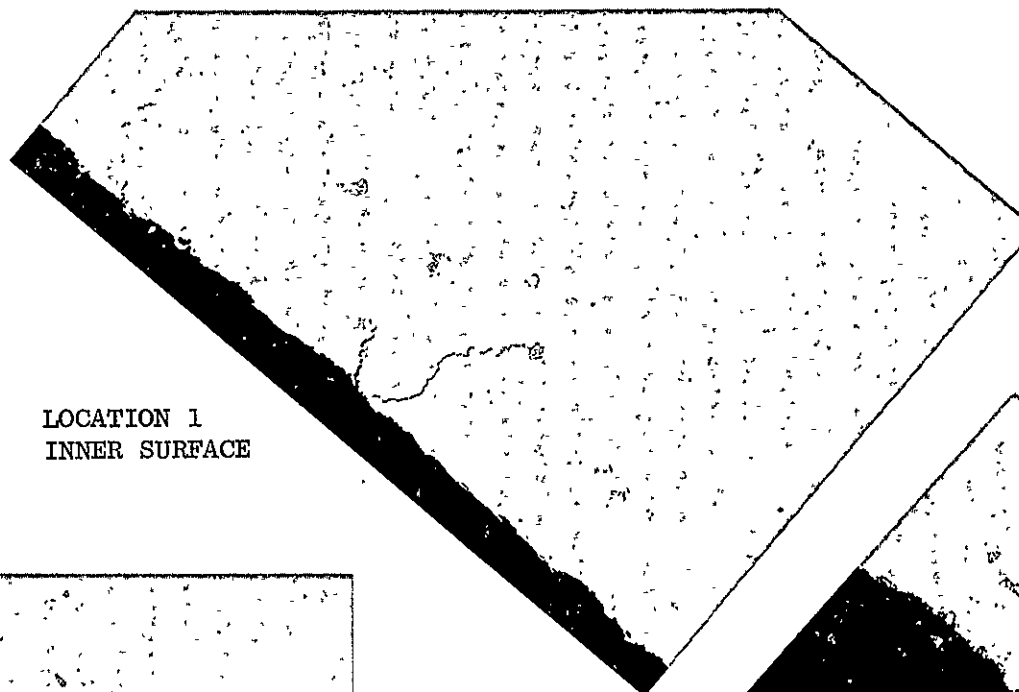
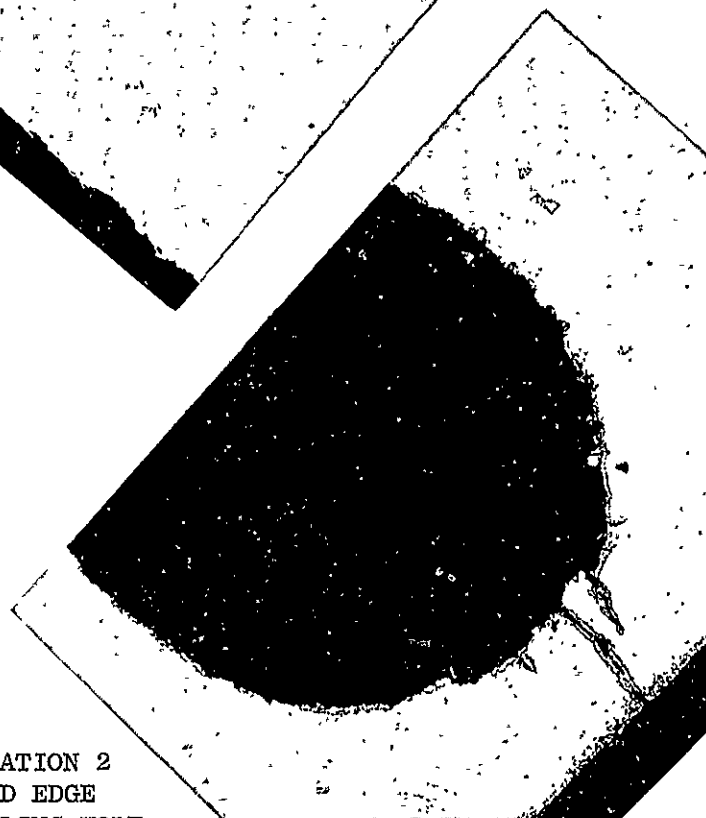
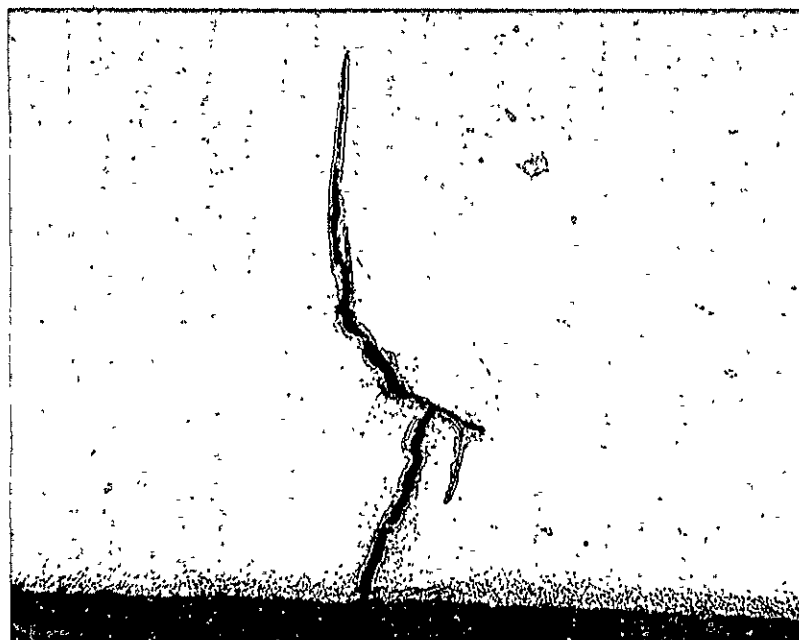
Figure 75 YD NiCrAl Lead Cavity Microstructures F101 HPT Test

LOCATION 1  
INNER SURFACE

LOCATION 2  
LEAD EDGE  
COOLING HOLE

LOCATION 3 OUTER SURFACE

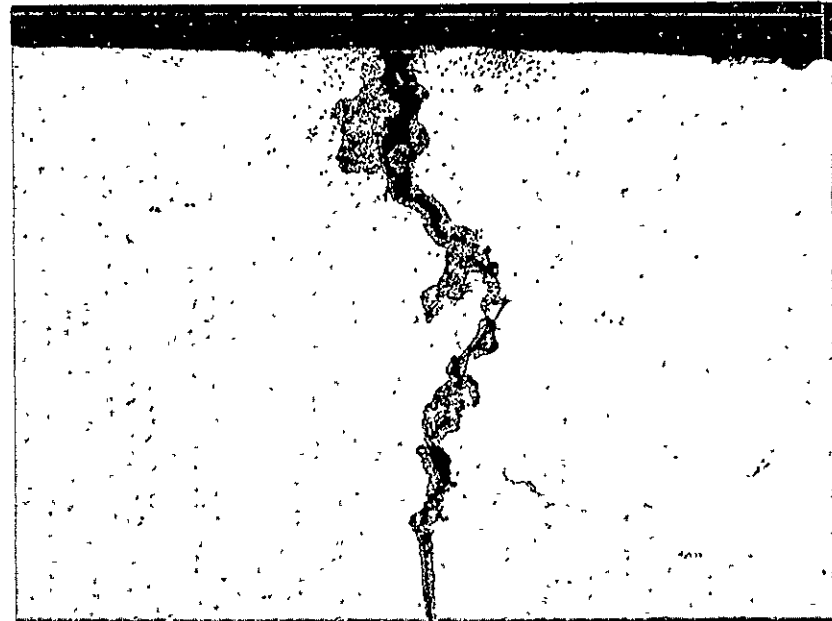
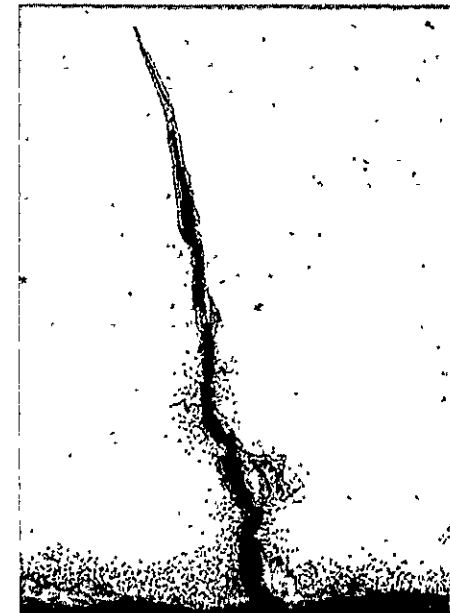
Figure 77 YD NiCrAl Trailing Edge Microstructures F101 HPT Test

LOCATION 9 SUCTION SIDE SURFACE 100X

LOCATION 8 PRESSURE SIDE SURFACE 100X

LOCATION 7 PRESSURE SIDE SURFACE 100X

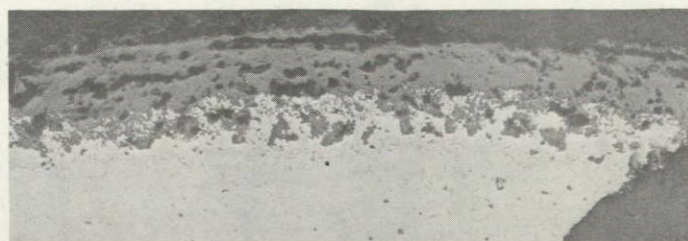
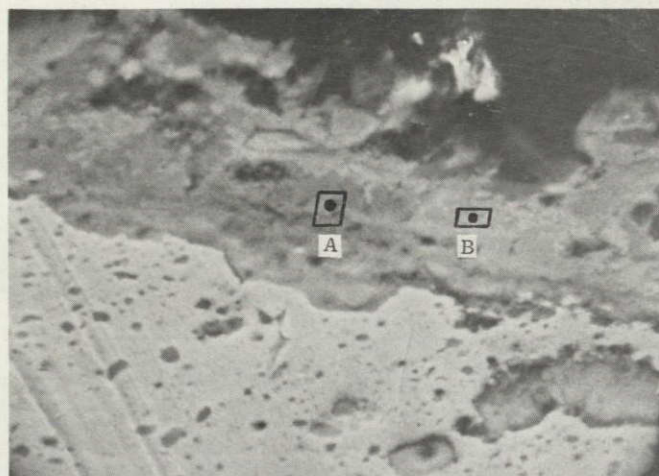
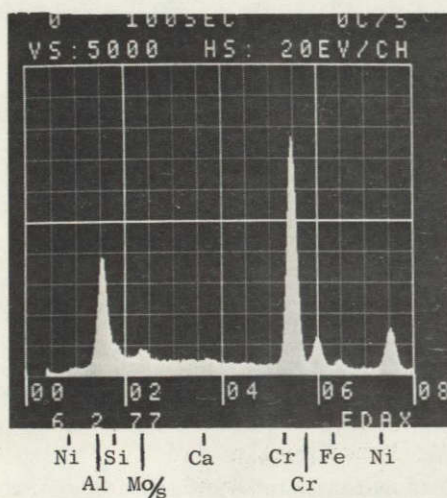
In another instance of aggravated oxidation, this time observed on a YD NiCrAl vane, iron was identified. It is speculated that, in this case, iron oxide (present in the test cell air environment) caused a destruction of the protective  $\text{Al}_2\text{O}_3$  on the vane. Figure 80 depicts the phenomenon in light microscopy, SEM, and EDAX.

LIGHT MICROSCOPY

SEM VIEW

AREA A EDAX

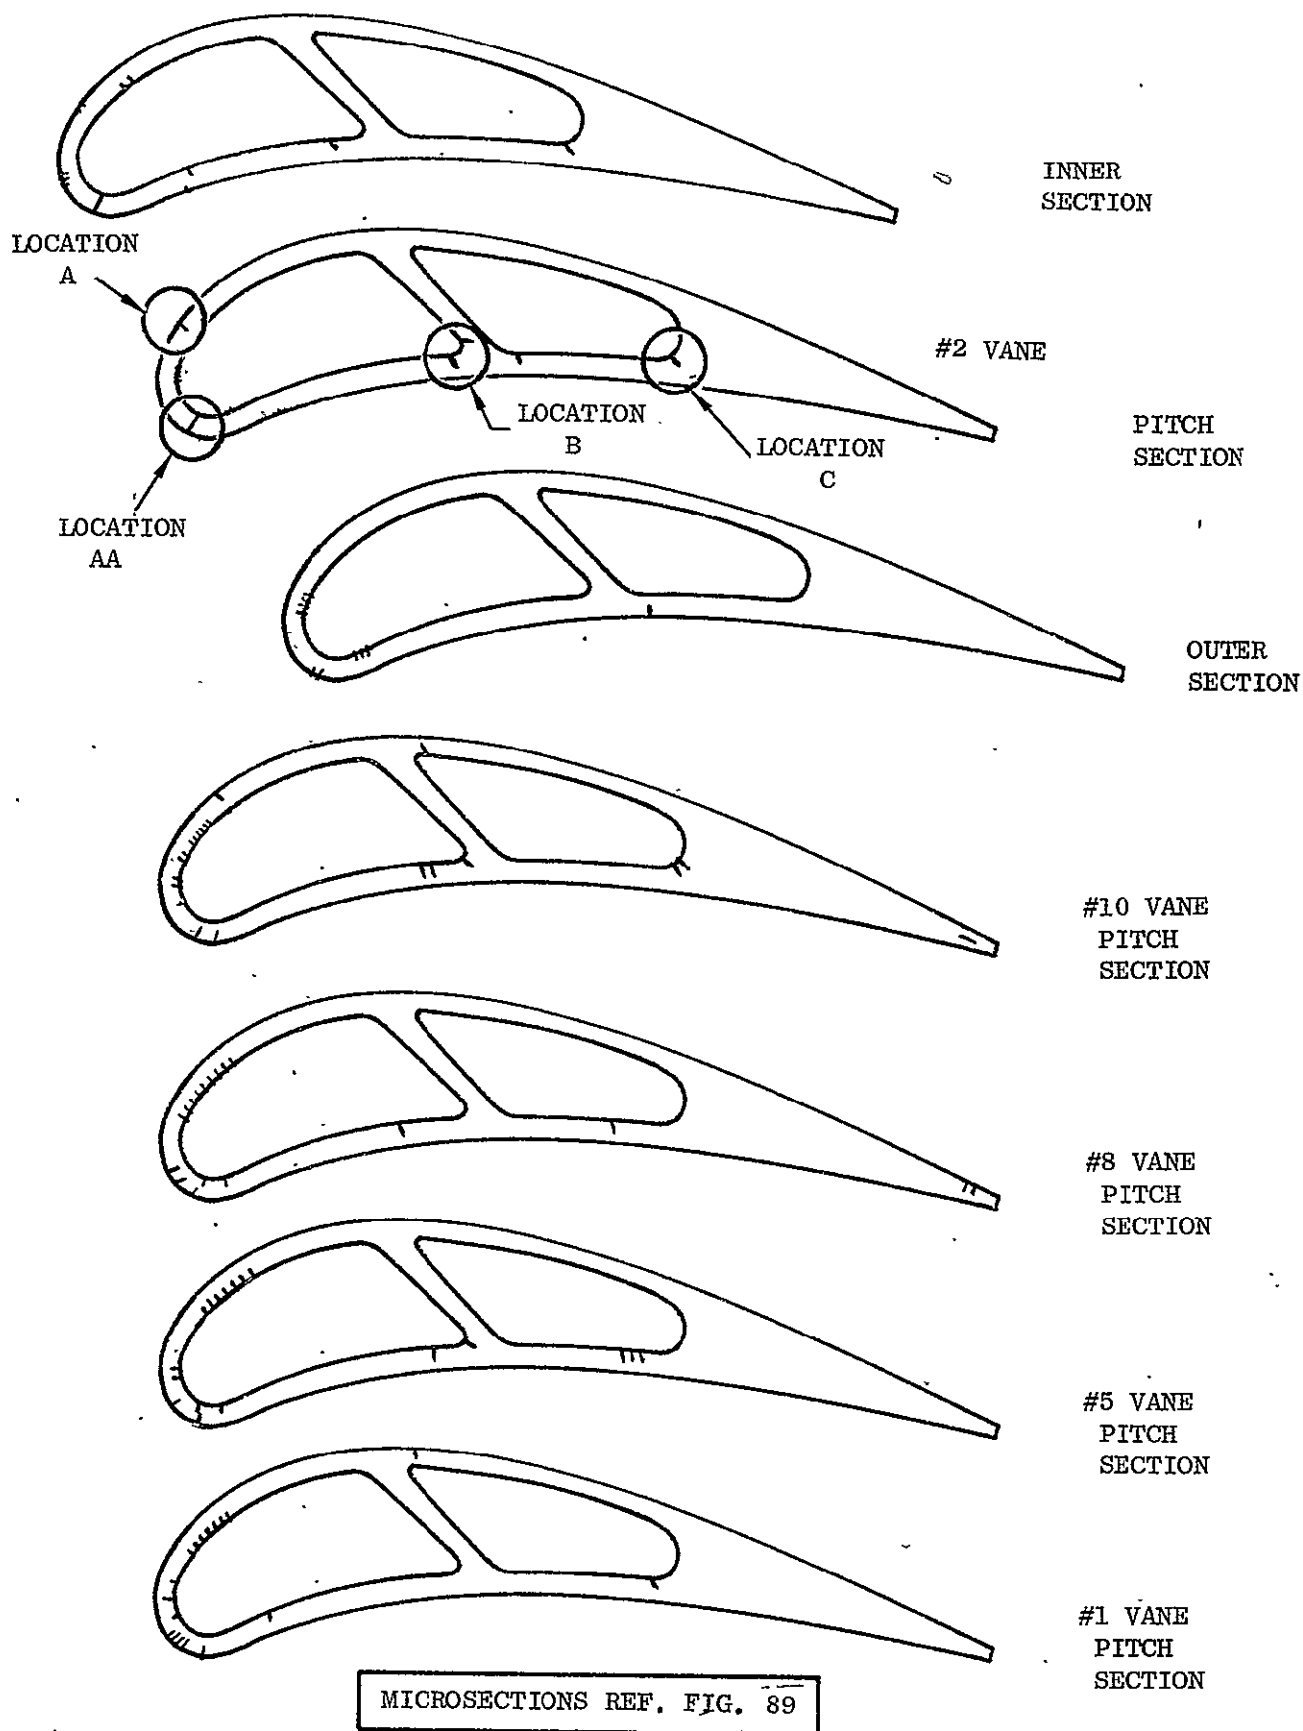
Figure 86 HDA8077 Vane Crack Locations CF6-50 Test

Because visible cracks were seen in some of the ODS vanes, it was decided to remove them for examination. Representative closeup views of the ODS vanes are displayed in Figures 83 through 85. A number of vanes were cut up for metallographic examination. These results are catalogued in Table 16. In general, the ODS vanes exhibited more cracking than the X-40 vanes. Among the ODS vanes, the HDA 8077 vanes cracked more severely than those made from MA 754 and YD NiCrAl. Crack locations are mapped for sections of the ODS vanes (Figures 86 through 88). In most cases, the pitch section (midway between bands) exhibited the most damage. Typical microsections of the three ODS alloy vanes are shown in Figures 89 through 91. In some cases, this

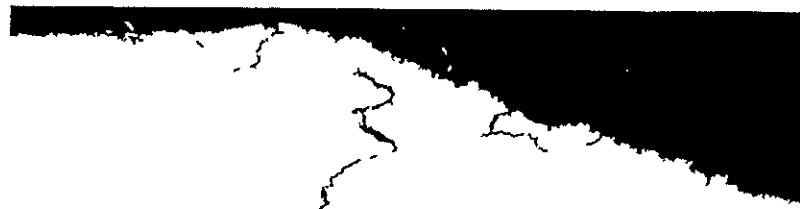
Figure 91 MA 754 Vane No. 4 Microsections CF6-50 Test

damage was manifested in through-the-wall cracking. In others it showed up simply as a greater quantity of cracks. Nearly all the cracking in all three ODS alloys was attributed by microevaluation to thermal gradients, causing stress rupture failure at grain boundaries. Gas pressure loads calculated are not large enough to cause the cracks. Very few fatigue-type cracks (transgranular) were observed in this engine test. Evidence of ODS alloy creep resistance is indicated in Figure 92. None of the ODS vanes showed any trailing edge bowing while several of the X-40 vanes did. This evidence is somewhat circumstantial, since it is possible that compressive stresses could have been more severe in the trailing vane (X-40) than in the leading vane locations of the ODS vanes.

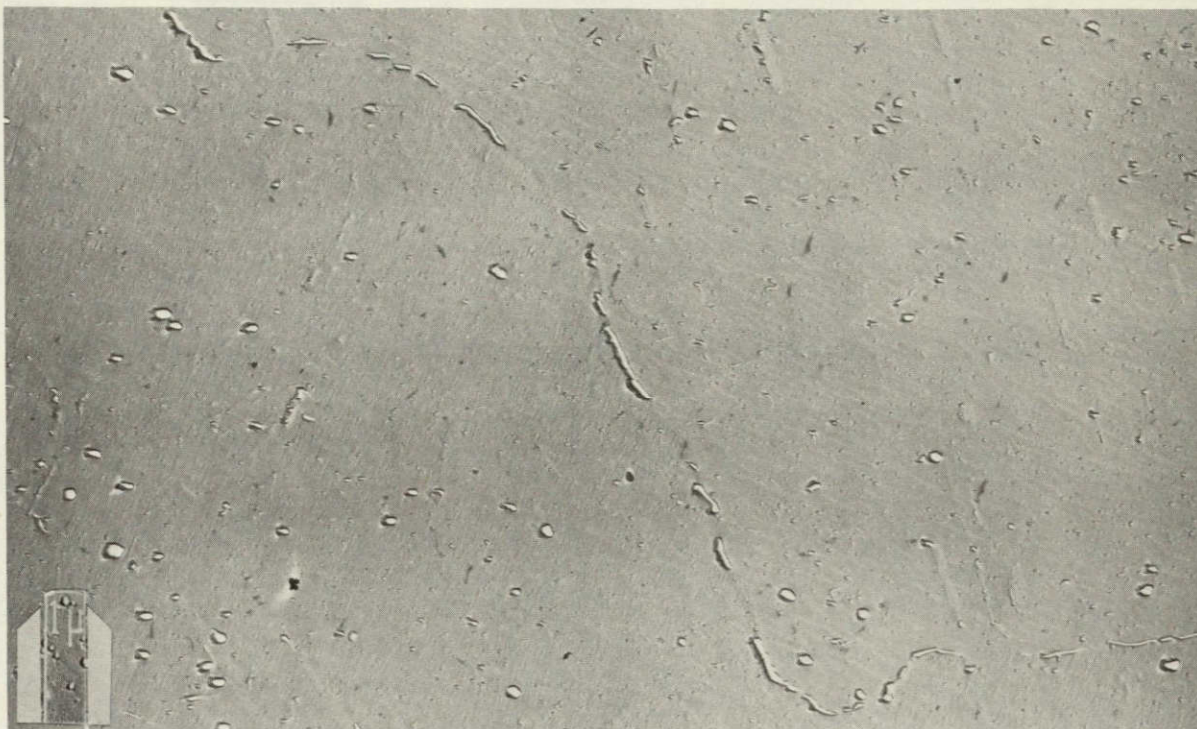
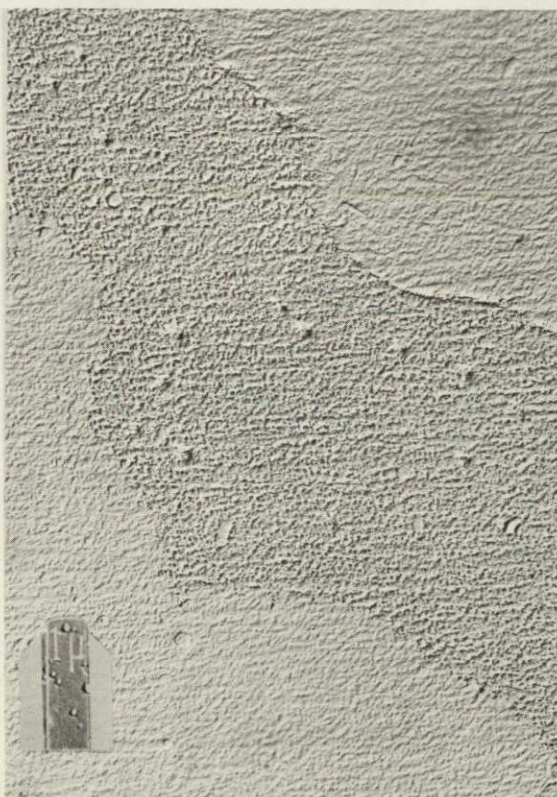
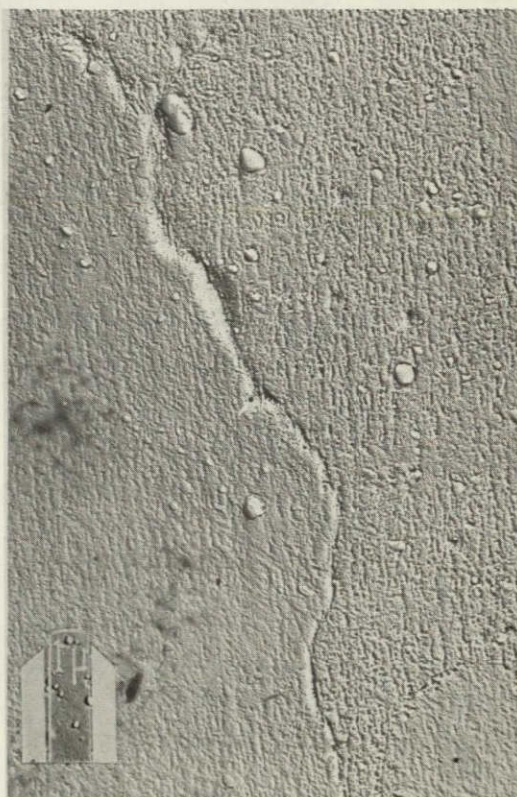
Figure 93 HDA 8077 & TD NiCrAl Grain Boundaries

Examination by replica electron microscopy did reveal a nearly continuous grain boundary phase in HDA 8077 that does not appear to be present in the other ODS-NiCrAl, YD NiCrAl and MA 754. Micrographs in Figures 93 and 94 show this and a similar, but much less, continuous phase in MA 754. Not much has been learned about this phase except that it appears to be rich in Chromium, as the SEM-EDAX analysis in Figure 95 indicates. Other analyses, however, show grain boundary phase compositions not substantially different from the matrix. Thus, circumstantial evidence appears to indicate that the presence of a grain boundary phase degrades the properties of HDA 8077 though the composition and source of the phase is unclear.
